## TECHNICAL SERVICE BULLETIN

### Water Dripping Onto The Front Passenger Side Footwell When A/C Is Operating - Built On/Or After 01-Feb-2013

**20-2382**05 November  
2020**Model:**

<b>Ford</b> 2014-2020 Transit Connect
--

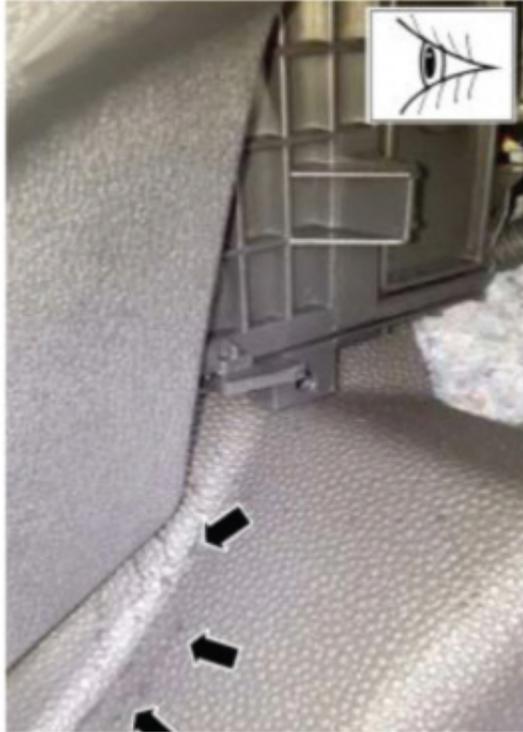
Figure 1

1. Is the concern as shown in Figure 1, water dripping onto the trim panel, or Figure 2, water dripping onto the floor covering?
